National Transportation Safety Board Aviation Accident Final Report

| Location: | St Louis, Missouri | Accident Number: | CEN15FA164 |
| Date & Time: | March 6, 2015, 23:10 Local | Registration: | N356AM |
| Aircraft: | Airbus Helicopters (Eurocopte EC-130-B4 | Aircraft Damage: | Destroyed |

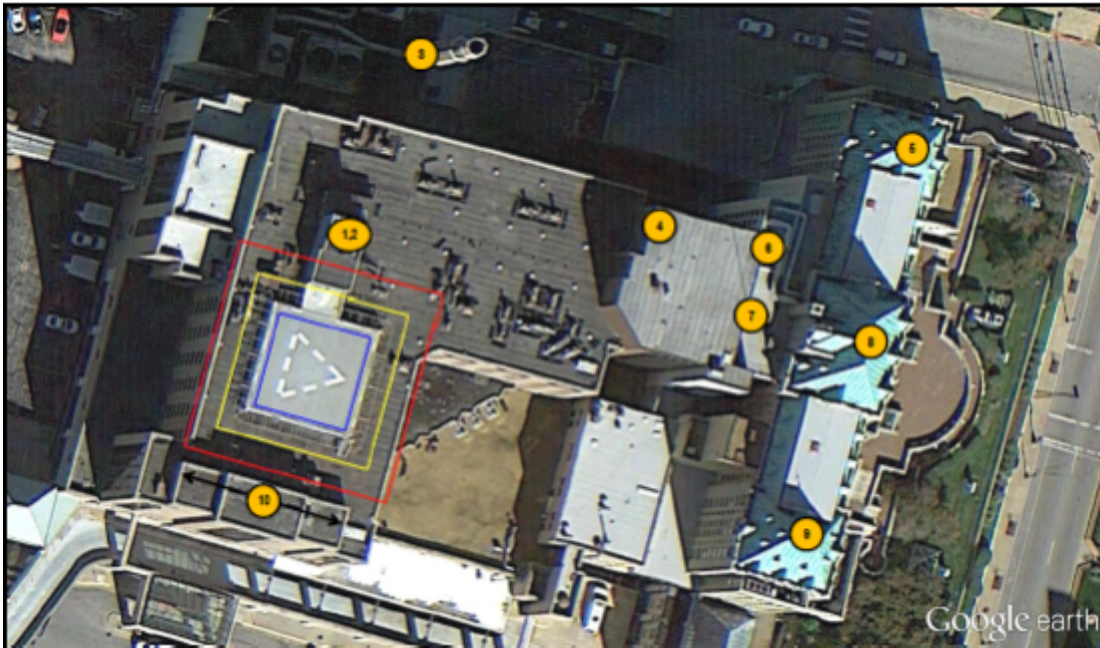
A postaccident safety evaluation of the heliport showed that the final approach and takeoff area/safety area were obstructed by permanent and semi-permanent objects that pose a serious hazard to helicopter operations. These obstructions limited the available approach paths to the heliport, which precludes, at times, approaches and landings with a headwind. The helipad is privately owned; therefore, it is not subject to Federal Aviation Administration (FAA) certification or regulation.

The NTSB IIC requested that the FAA perform post-accident inspection of MO55, which was performed on April 16, 2015. The inspection results were documented in a Heliport Safety Evaluation Report, Case Number: 2015–ACE–1749–NRA. The report cited 10 obstructions within the final approach and takeoff area (FATO)/safety area of the heliport/helipad and 4 obstructions outside the FATO/safety area. The 10 obstructions outside the FATO/safety area had a ranged in azimuth from 005 – 236 degrees and there were no obstructions from 236 – 005 degrees, or west, northwest.

Figure 1: Obstructions Outside the FATO/Safety Area

"The heliport FATO/safety area is obstructed by permanent and semi-permanent objects that pose a

serious hazard to helicopter operations. The most serious obstructions cannot be easily lowered or removed. Flight Standards cannot recommend an approach/departure route into or out of a hazardous area that does not appear to have reasonable alternatives for mitigation. Therefore, no recommendation for ingress/egress is made in this case."

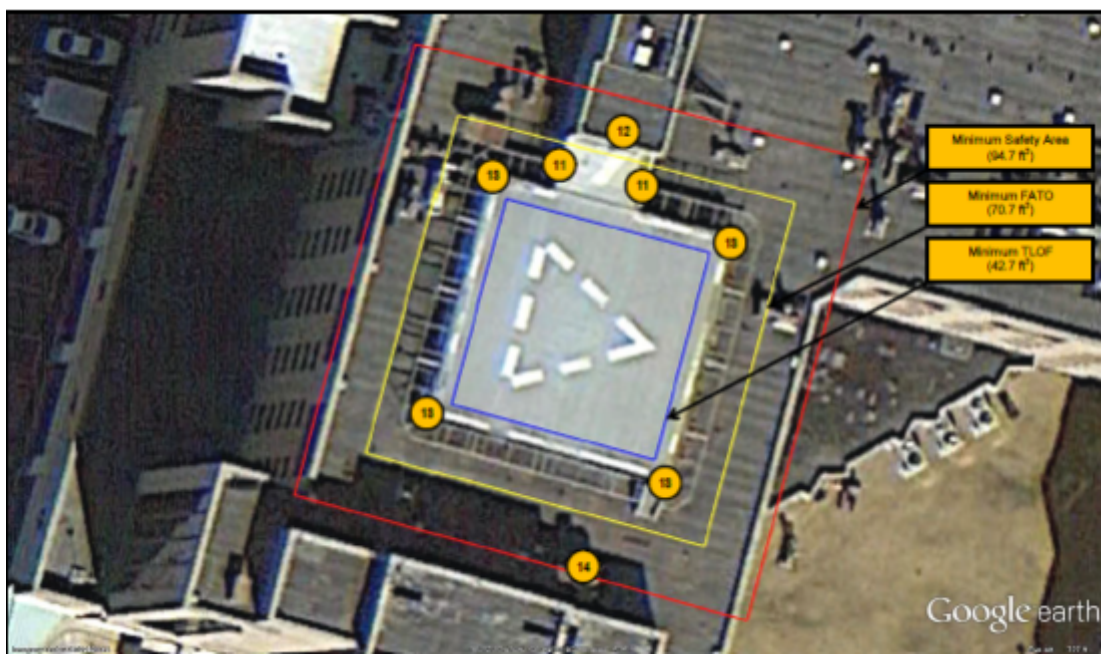
Figure 2: Obstructions Inside the FATO/Safety Area

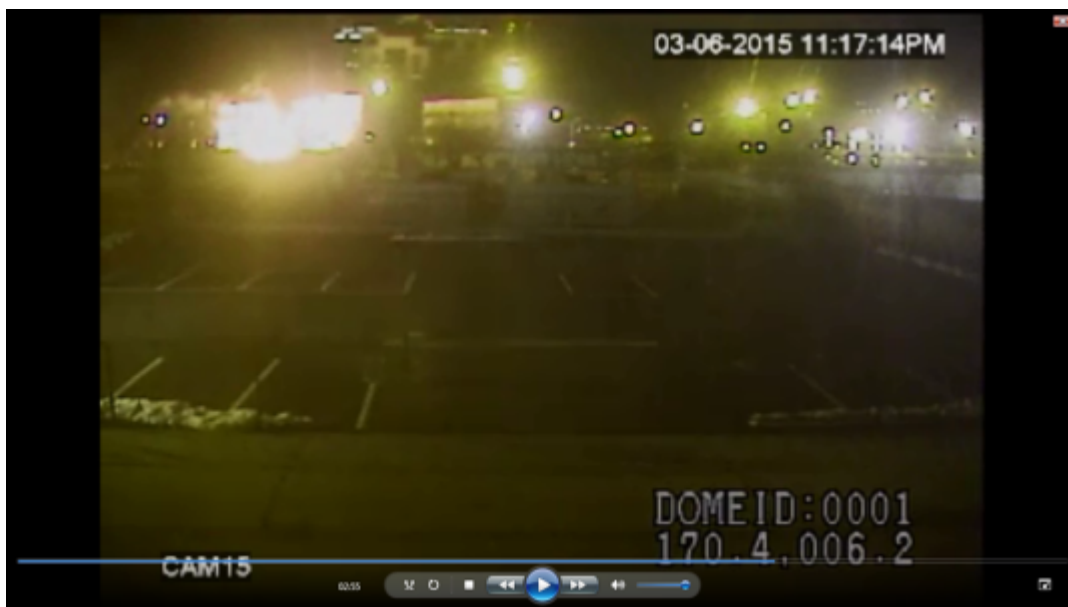
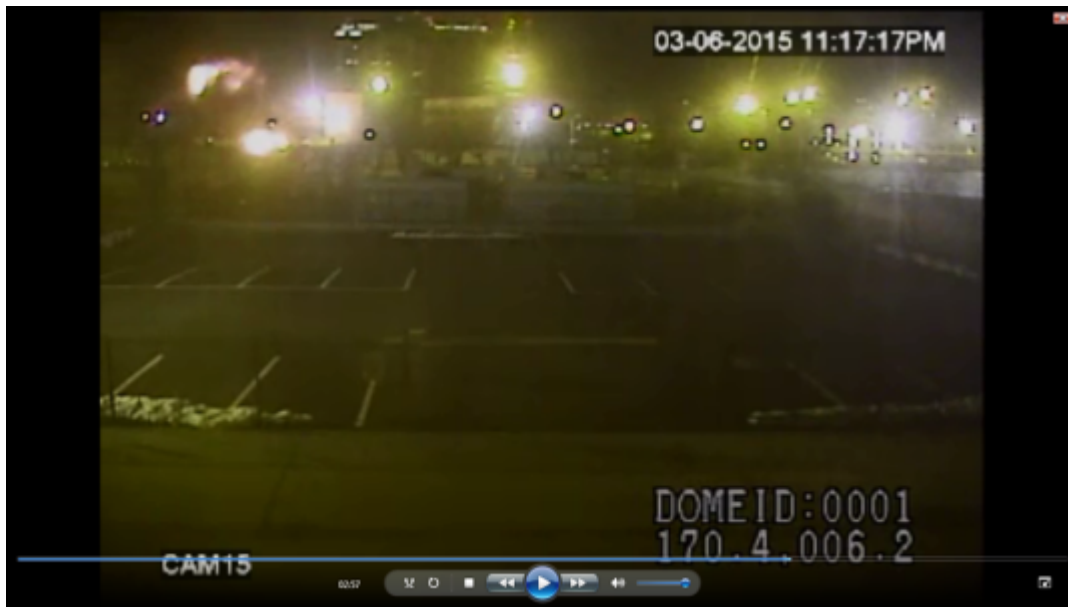
A post-crash fire and explosion occurred upon impact when the helicopter impacted the parking lot adjacent to the building entrance which was captured by a security video. The following two frames from a security camera show the explosion and fire that ensued after the helicopter's impact.

Figure 3: The top video frame at 11:17:14 PM shows the fire/explosion during the impact of N356AM and the bottom frame at 11:17:17 PM shows a fire ball separated from the initial fire and moved upwards and to the left of the screen in a direction consistent with approximate wind direction.

On March 23, 2016, the NTSB issued Safety Recommendations A-16-11 and A-16-8 through -10 pertaining to Airbus Helicopters EC-130-B4 and AS-350-B3e. Two 2015 accidents, one of which involved N356AM, had impact forces survivable for occupants but fatal and serious injuries occurred because of postcrash fires that resulted from an impact-related breach in the fuel tanks.

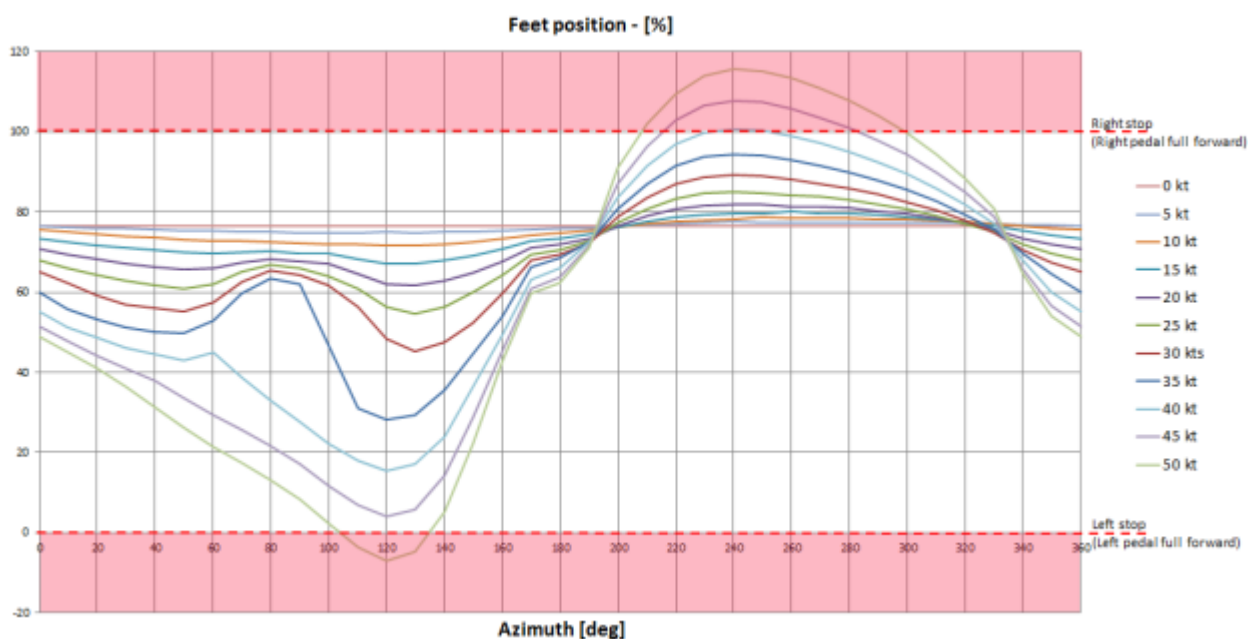
During the accident investigation, the NTSB Investigator-In-Charge requested that Airbus Helicopters perform a critical azimuth analysis and in response to that request, Airbus Helicopters provided the following charts showing pedal control and power required to maintain an out of ground effect hover relative to azimuth/wind speed.

Figure 4: The plot shows percentage of foot position versus azimuth at wind speeds from 0-50 knots. The left stop limit occurs at azimuths of about 103 degrees to 138 degrees with a wind of 50 knots. The right pedal stop occurs at azimuths of about 230 degrees to 253 degrees at a wind speed of 40 knots; the azimuth range for the right pedal stop increases with increasing wind speeds of 45 knots and 50 knots.

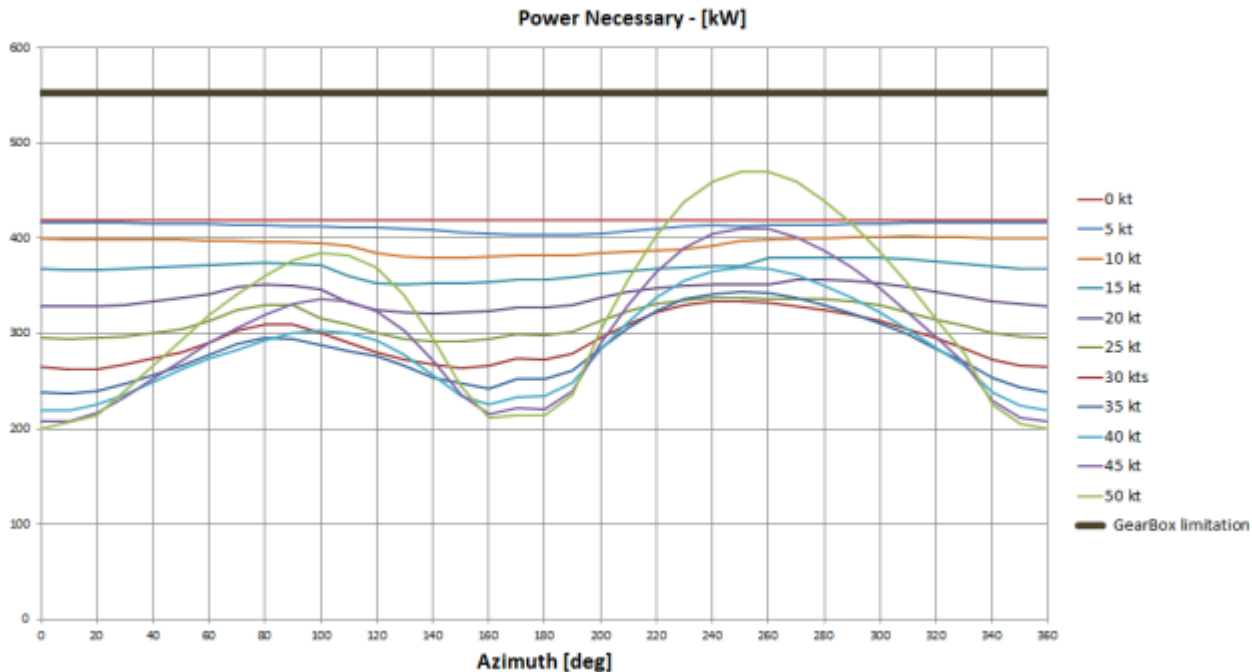
Figure 5: Plot of power necessary versus azimuth at wind speeds from 0-50 knots. The upper limit of power occurred at approximate azimuth of 223 degrees to 290 degrees with a wind speed of 50 knots.
