# National Transportation Safety Board Aviation Accident Final Report

<b>Location:</b>	Superior, Arizona	<b>Accident Number:</b>	WPR16FA040
<b>Date &amp; Time:</b>	December 15, 2015, 17:23 Local	<b>Registration:</b>	N74317
<b>Aircraft:</b>	AIRBUS Helicopters AS350	<b>Aircraft Damage:</b>	Substantial
<b>Defining Event:</b>	Low altitude operation/event	<b>Injuries:</b>	2 Fatal, 1 Serious
<b>Flight Conducted Under:</b>	Part 135: Air taxi & commuter - Non-scheduled - Air Medical (Discretionary)

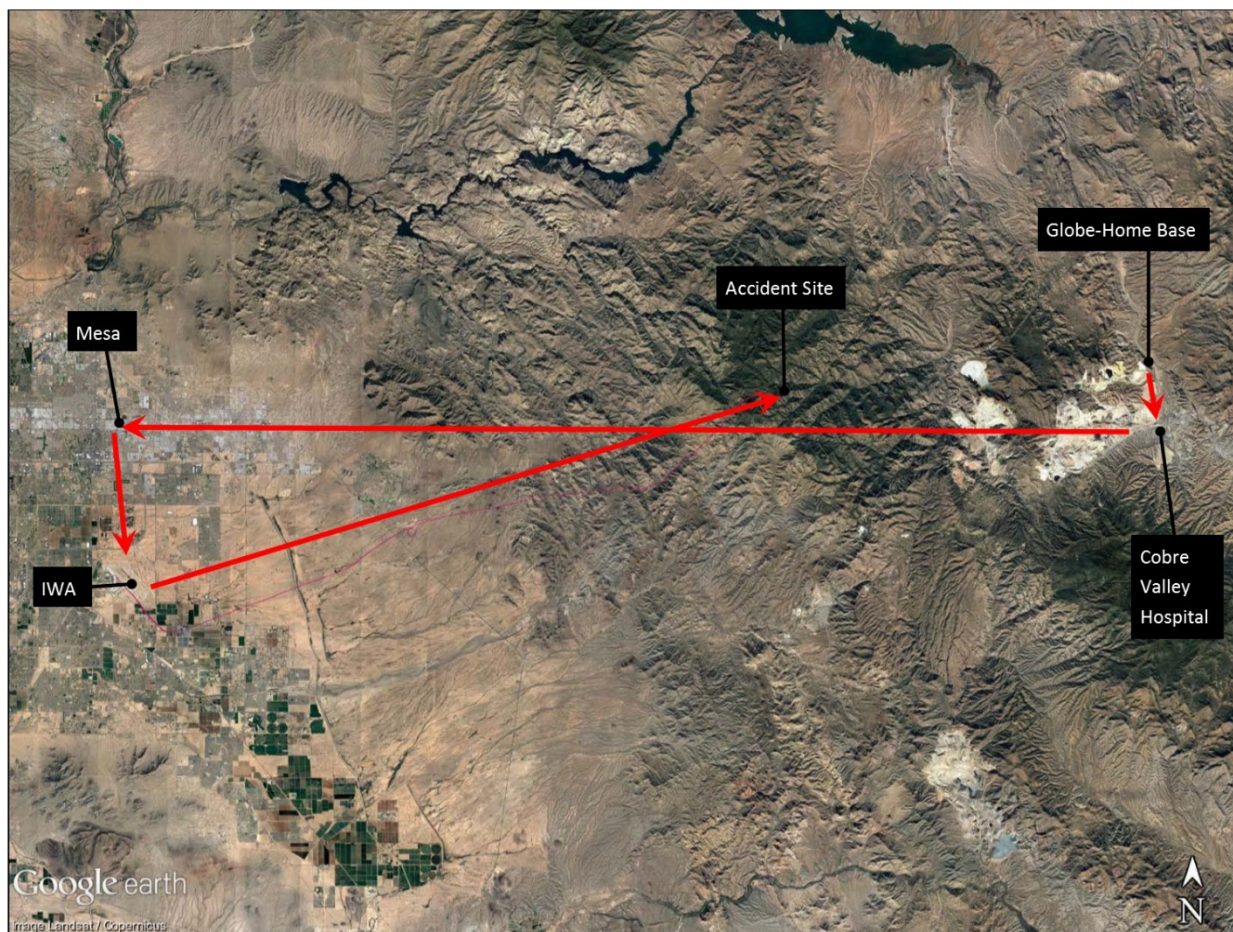
Figure 1-Overview of Flights

According to the operator, the helicopter was based in Globe and had transported a patient from the Cobre Valley Community Hospital in Globe to the Baywood Heart Hospital in Mesa. After transporting the patient, the pilot flew the helicopter to IWA for refueling before the return flight to Globe. (See figure 1)
