# National Transportation Safety Board

## Aviation Accident Final Report

<b>Location:</b>	New Castle, Delaware	<b>Accident Number:</b>	ERA17FA190
<b>Date &amp; Time:</b>	May 25, 2017, 11:53 Local	<b>Registration:</b>	N62UP
<b>Aircraft:</b>	EUROCOPTER DEUTSCHLAND GMBH EC 135	<b>Aircraft Damage:</b>	Destroyed
<b>Defining Event:</b>	Loss of control in flight	<b>Injuries:</b>	1 Fatal
<b>Flight Conducted Under:</b>	Part 91: General aviation - Personal

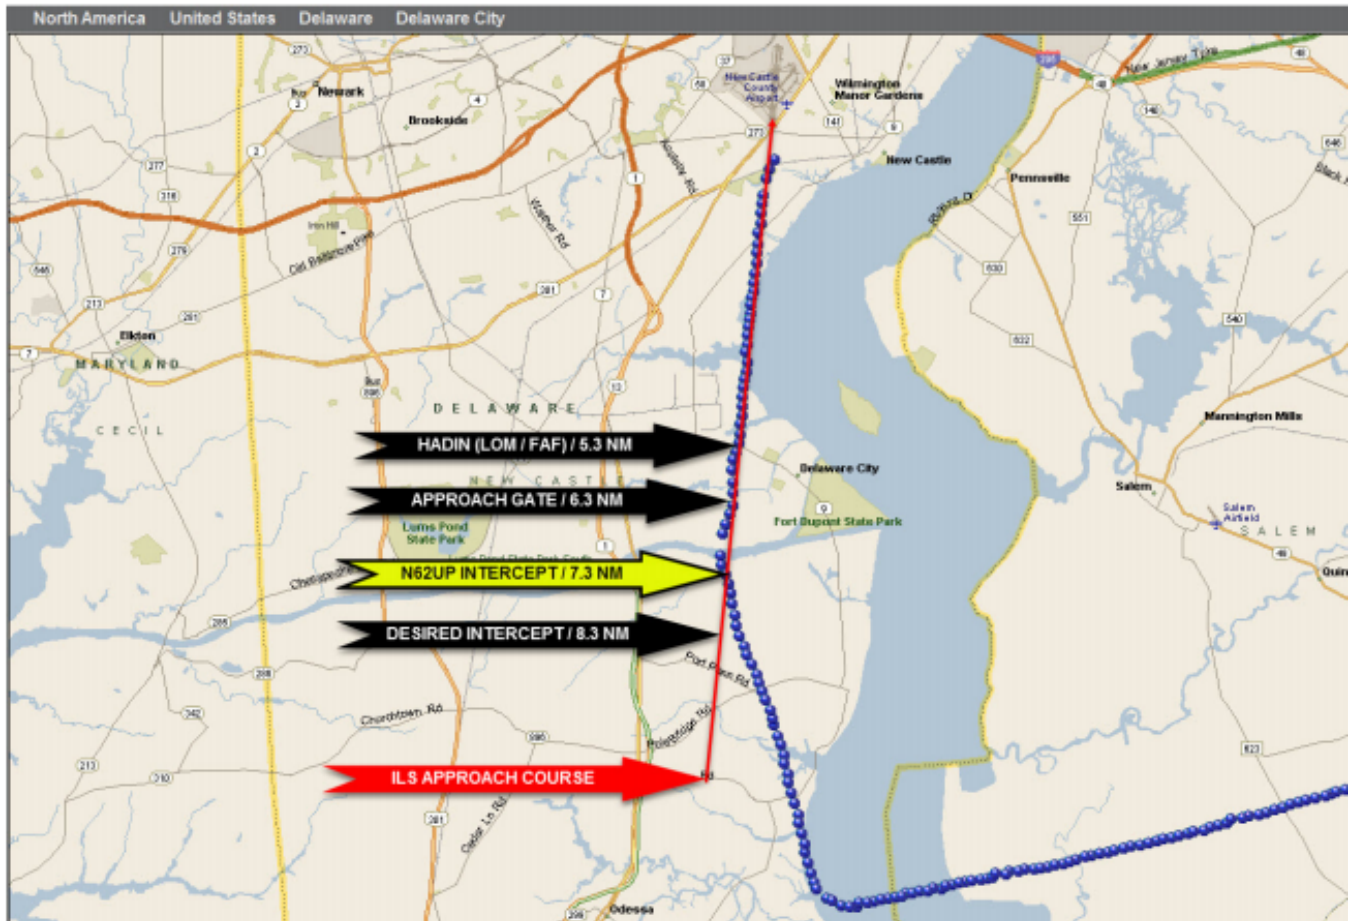
Although the radar vectors provided by the controller during the approach were contrary to the FAA's guidance to air traffic controllers, which required aircraft to be vectored to intercept an ILS localizer course 2 nm outside the approach gate given the weather conditions that prevailed at that time, radar data confirmed that the helicopter successfully tracked inbound toward the airport on the localizer course. Although the radar vectors did not directly contribute to the accident, they likely increased the pilot's task load during the accident sequence.

Figure 2. Radar flight track of the final segment of the accident flight. Key points along the route of flight have been depicted in order to illustrate the final approach intercept with relation to the final approach fix and approach gate.
