# National Transportation Safety Board

## Aviation Accident Final Report

<b>Location:</b>	Hertford, North Carolina	<b>Accident Number:</b>	ERA17MA316
<b>Date &amp; Time:</b>	September 8, 2017, 11:20 Local	<b>Registration:</b>	N146DU
<b>Aircraft:</b>	EUROCOPTER DEUTSCHLAND GMBH MBB BK 117	<b>Aircraft Damage:</b>	Destroyed
<b>Defining Event:</b>	Loss of engine power (partial)	<b>Injuries:</b>	4 Fatal
<b>Flight Conducted Under:</b>	Part 135: Air taxi & commuter - Non-scheduled - Air Medical (Discretionary)

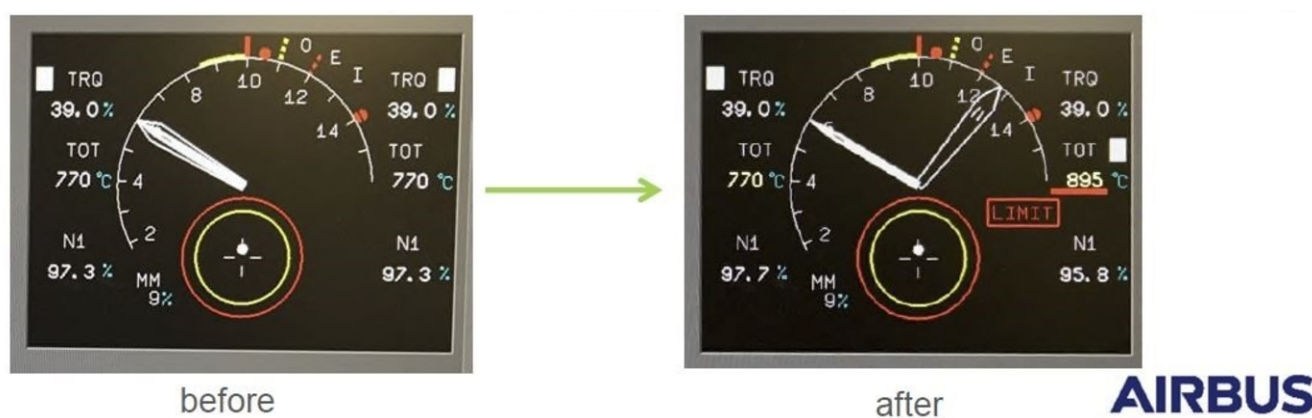
**Figure 3 - Simulated FLI display before and during rear bearing seizure.**

Specifically, as the bearing failed, the FLI needle for the No. 2 engine would have changed from indicating torque (TRQ), to indicating turbine outlet temperature (TOT) due to a sudden rise in TOT in the No. 2 engine. Such a switch would have been unusual, because the needles normally reflect TOT during engine start only. The change in the position of the No. 2 FLI needle would have resulted in a large split between both needles.

Airbus Helicopters performed a computer simulation to determine what the FLI might theoretically indicate in the event of a gas generator rear bearing seizure in the No. 2 engine. The simulation assumed that the gas generator continued to rotate momentarily with damage to the high-pressure turbines and without friction in the seized rear bearing. Figure 3 shows a representation of the FLI before and during such a rear bearing seizure. Airbus Helicopters noted that this simulation depicted a snapshot of the simulated conditions and that, during operations, the needles would move and numeric values would fluctuate based on the engine parameters, the power applied, and the evolution of the bearing failure.

The left image of figure 3 shows the FLI with the engine operating normally, prior to a bearing seizure. Both FLI needles should depict TRQ because that would be the first limiting parameter for both engines in the flight conditions on the day of the accident. The needles would both indicate the same or nearly the same value for TRQ because both engines should produce about the same power, as the engines are TRQ balanced by the VARTOMS system. The simulation showed that, with a rear bearing seizure in the No. 2 engine, the engine's turbine outlet temperature would be elevated such that the TOT limit would be reached before the torque limit. Thus, an elevated turbine outlet temperature would result in the FLI changing to TOT for the No. 2 engine, as denoted by the white box for the No. 2 engine moving from the TRQ label (in the left image) to the TOT label (in the right image) and the position of the needle for the No. 2 engine changing. In addition, because TOT reached its limit, the digital value appeared with a red bar underneath it. The No. 1 engine would remain limited by TRQ, as indicated by the white box for the No. 1 engine next to the TRQ label (in the right image). As a result, a large split in the needles would occur because they would no longer indicate the same parameter for each engine, even though both engines would still be initially producing the same torque (39% in the figure).
